## HAZARD RANKING SYSTEM (HRS) DOCUMENTATION RECORD COVER SHEET

**Name of Site:** Southside Chattanooga Lead Site

## HAZARD RANKING SYSTEM (HRS) DOCUMENTATION RECORD

Date Prepared: January 2018

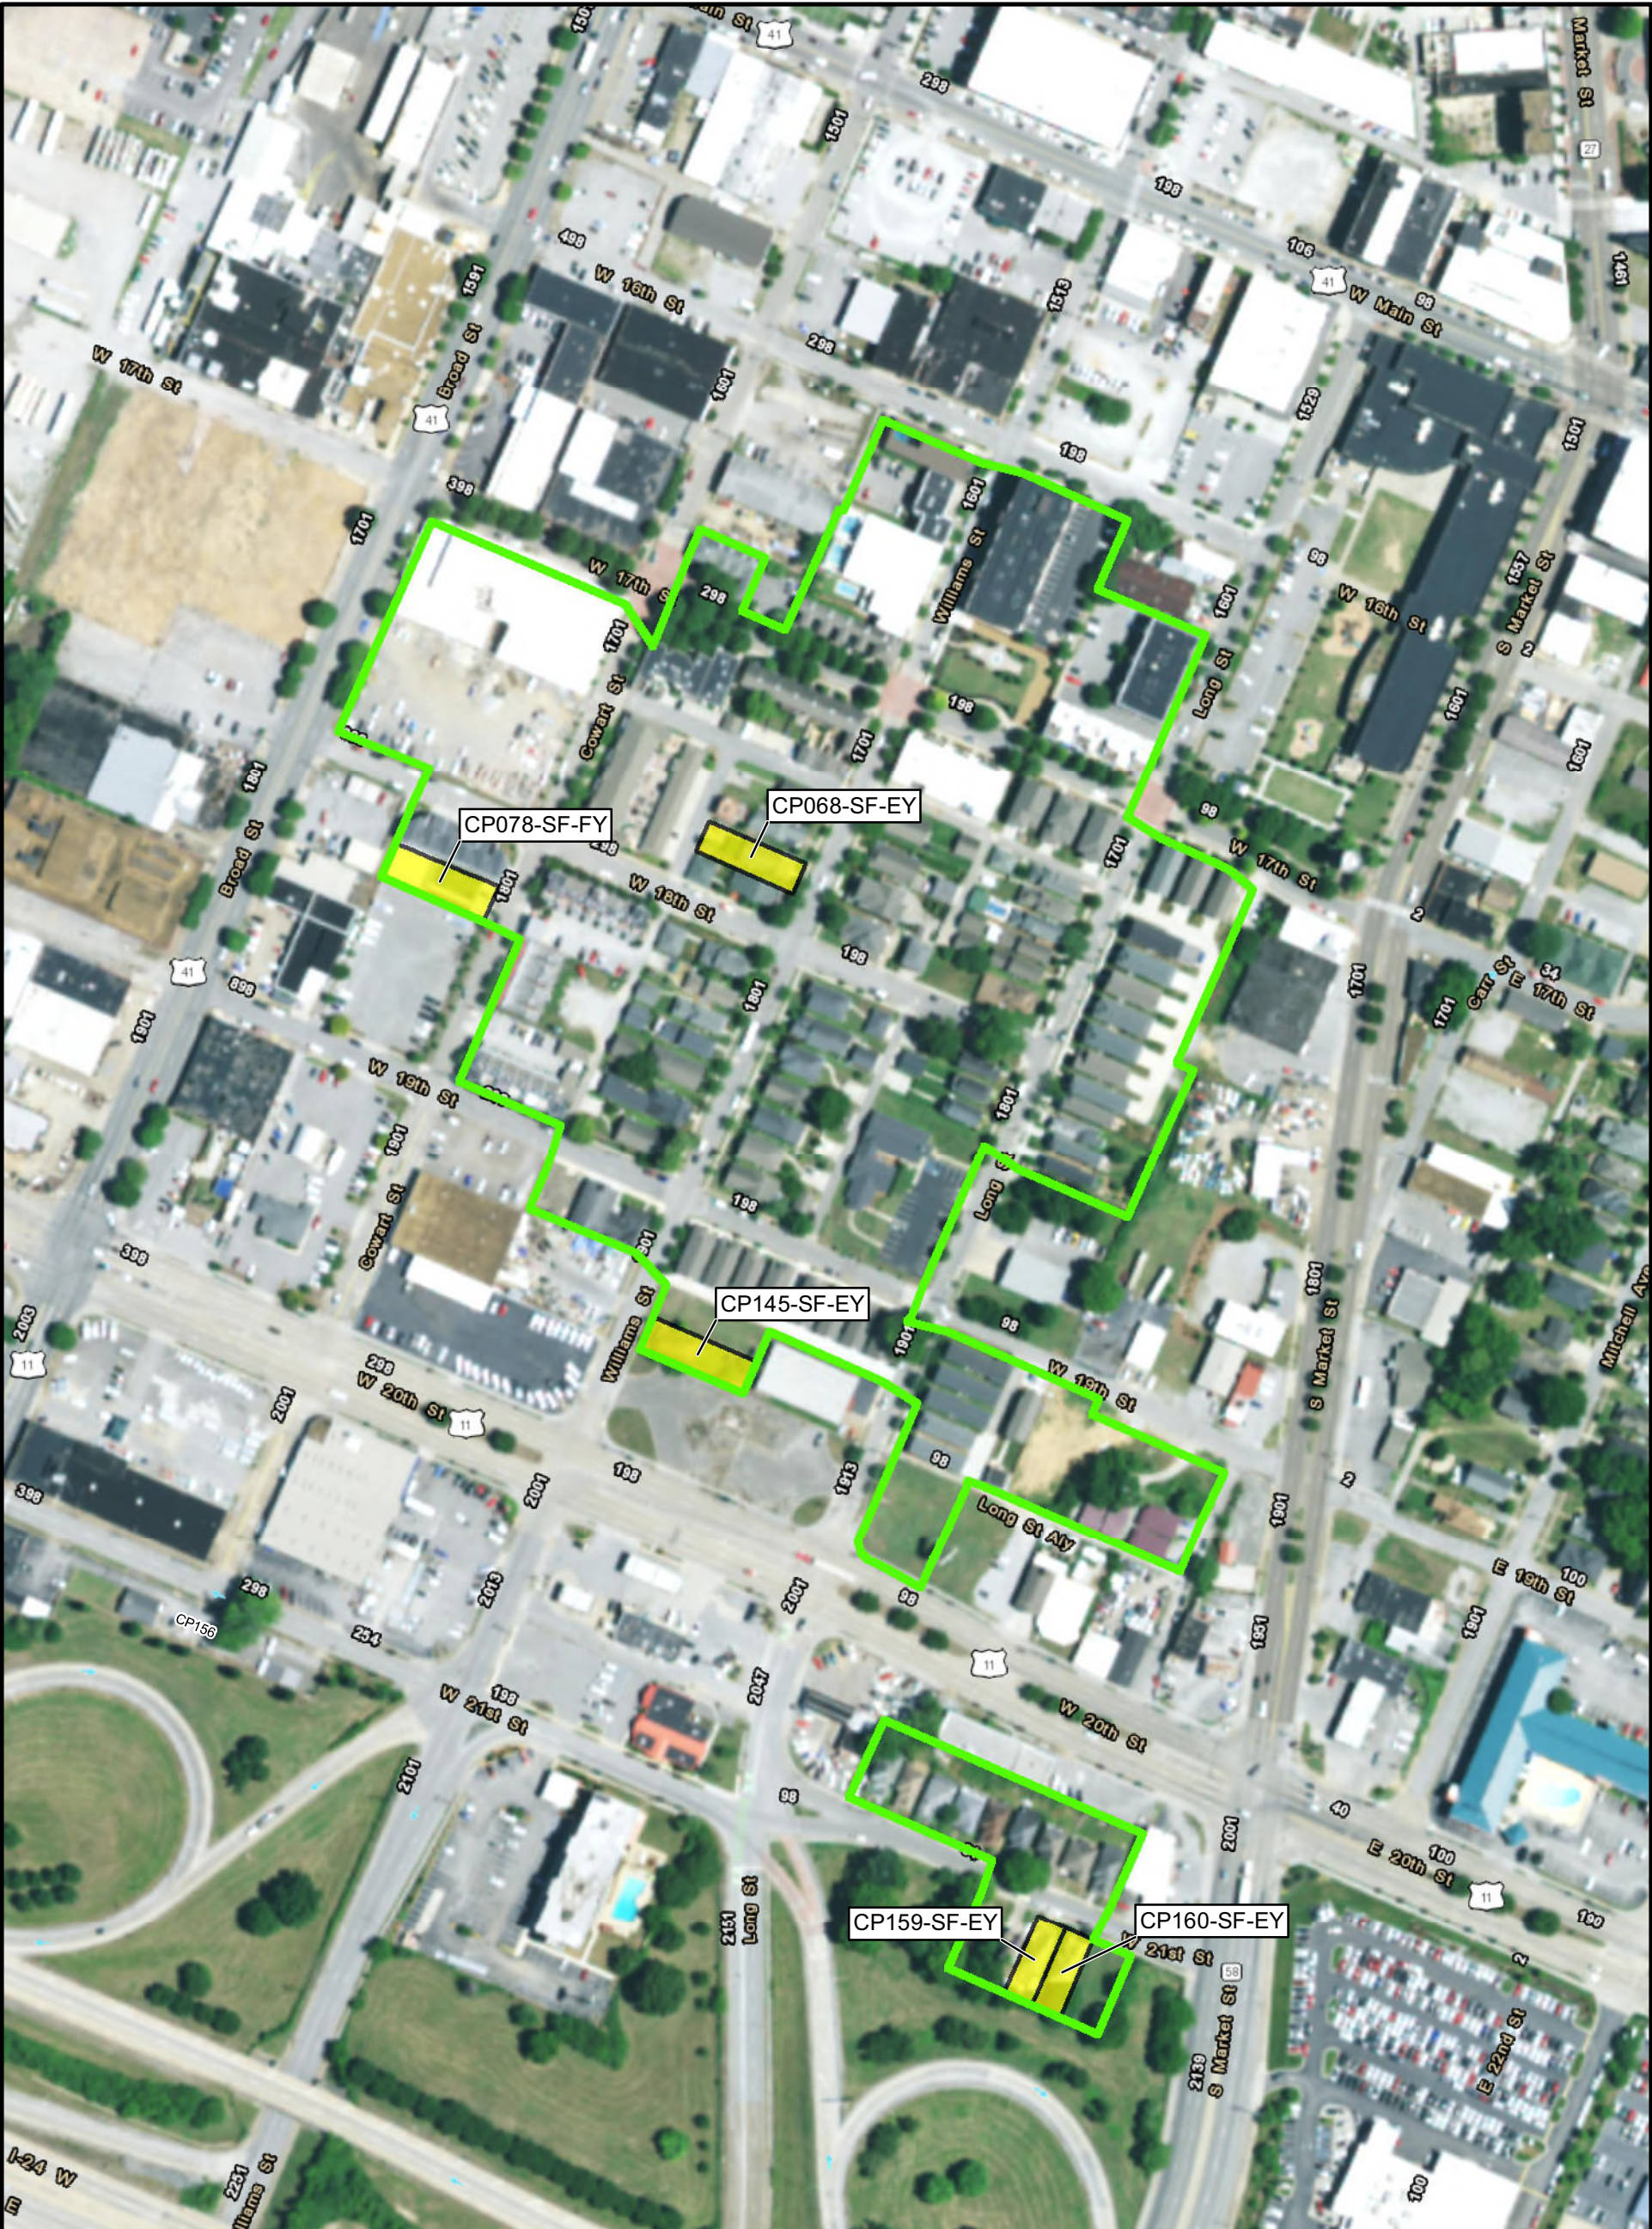
Cowart Place  
Area of Observed Contamination
